Manhole Inspection Summary

Manhole # S33Y1_003MH

Insp Date: **11/29/07 2:11 PM**

Location Address: **115 Riverside Road**

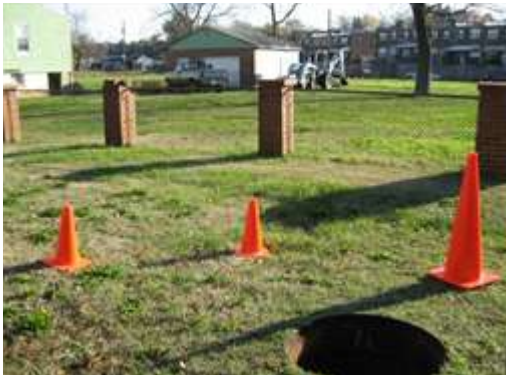
Location View

150 feet west from 115 Riverside Road

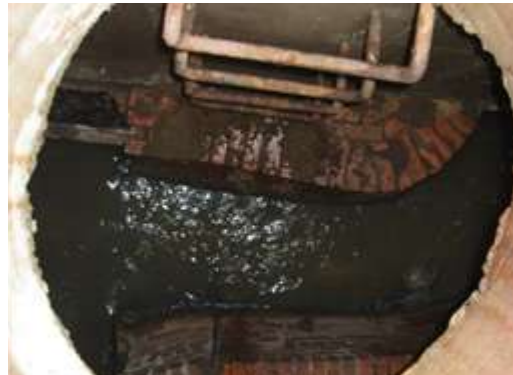
Top View

Comments **Effluent and Influent pipes could not be measured due to the angle of the manhole. Estimated to be 27 and 21 inches respectively according to the GIS. Invert depth is about 10.41ft.**

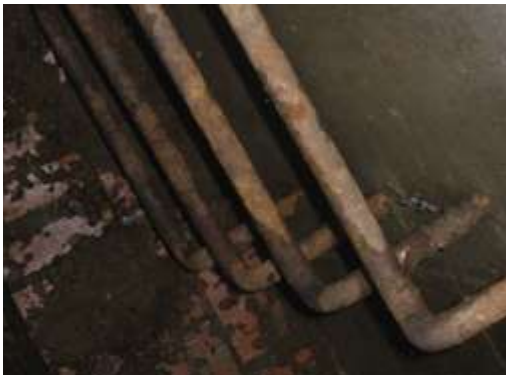
Defect 1

corroded steps

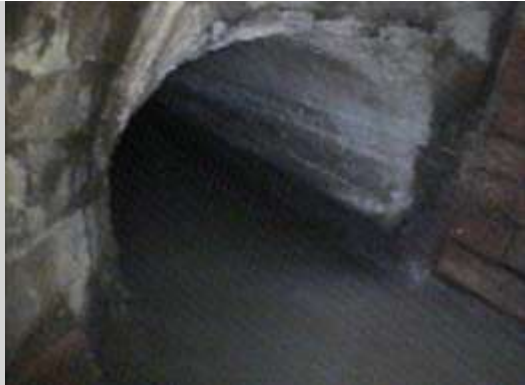
12 O'Clock Outflow

21 in. Circular Gravity Sewer
Pipe Out @ 12 O'Clock

Pipe Material: **Concrete** ☐ Pipe Lined

Infiltration: **None** Pipe Seal Cond: **Sound**

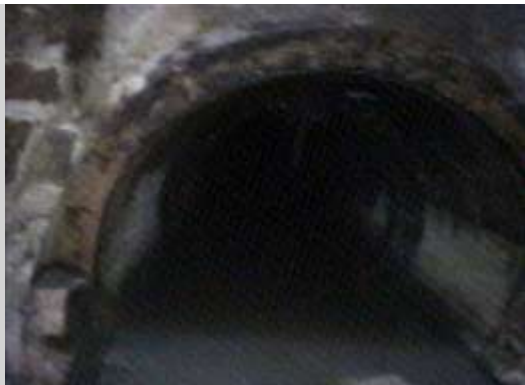
6 O'Clock Inflow

27 in. Circular Gravity Sewer
Pipe In @ 6 O'Clock

Pipe Material: **Clay** ☐ Pipe Lined

Infiltration: **None** Pipe Seal Cond: **Sound**
